ASSESSMENT ON THE IMPACT OF THE TRIPURA EARTHQUAKE (JANUARY 3, 2017, $M_w = 5.6$) IN NORTHEAST INDIA

Abstract: The northeastern part of the Indian subcontinent, considered as the most active seismic zone of the Indian subcontinent, was hit by an earthquake of M_w 5.6 on January 3, 2017. The epicenter of this earthquake was Kanchanbari located in the Dhalai district of Tripura. The present study aims to assess the environmental and socio-economic impact of this earthquake in the vicinity of the epicenter. To assess and determine the level of damage, the affected areas were visited during the first week of the 2017 earthquake. Various Government offices were also consulted to acquire data on damages caused by the earthquake. Moreover, Remote Sensing and Geographical Information System (RS & GIS) techniques were applied to address the influence of this earthquake on bank erosion. During the field visit, the striking features of soil liquefaction generated by the earthquake were observed in the flood plain area of the Manu River. Landslide, with three casualties in India and the neighbor Bangladesh, and damages of infrastructure were also reported. Additionally, an assessment of the b

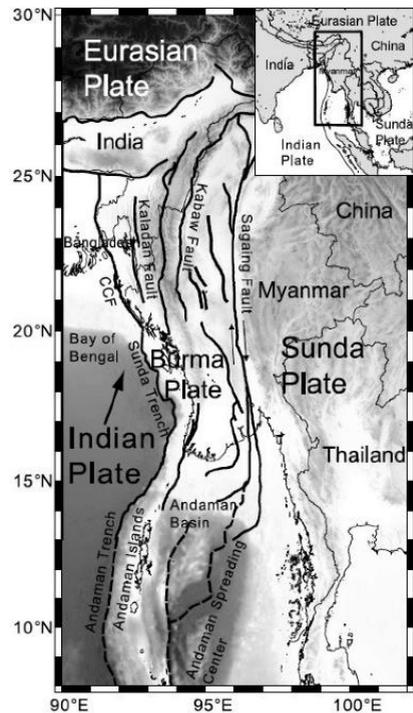
Figure 2. Tectonic setting of the Northeastern region of India. From "Detailed geometry of the subducting Indian Plate beneath the Burma Plate and subcrustal seismicity in the Burma Plate derived from joint hypocenter relocation" by N. Hurukawa, P. P. Tun, and B. Shibazaki, 2012, *Earth Planets Space*, 64(4), p. 334. Copyright 2012 by The Society of Geomagnetism and Earth, Planetary and Space Sciences (SGEPSS); The Seismological Society of Japan; The Volcanological Society of Japan; The Geodetic Society of Japan; The Japanese Society for Planetary Sciences; TERRAPUB.

The focal depth was 31 km according to National Center for Seismology, India (Table 1). The state of Tripura is located in the Indo-Burma wedge, and occurrences of crustal deformation and associated seismicity have become a significant concern. According to the previous researches of Le Dain, Tapponnier, and Molnar (1984) and Gahalaut (2010), the main reason for such crustal deformation and associated seismicity occurrence is the interaction of the Indian and Sunda Plate (Figure 2).

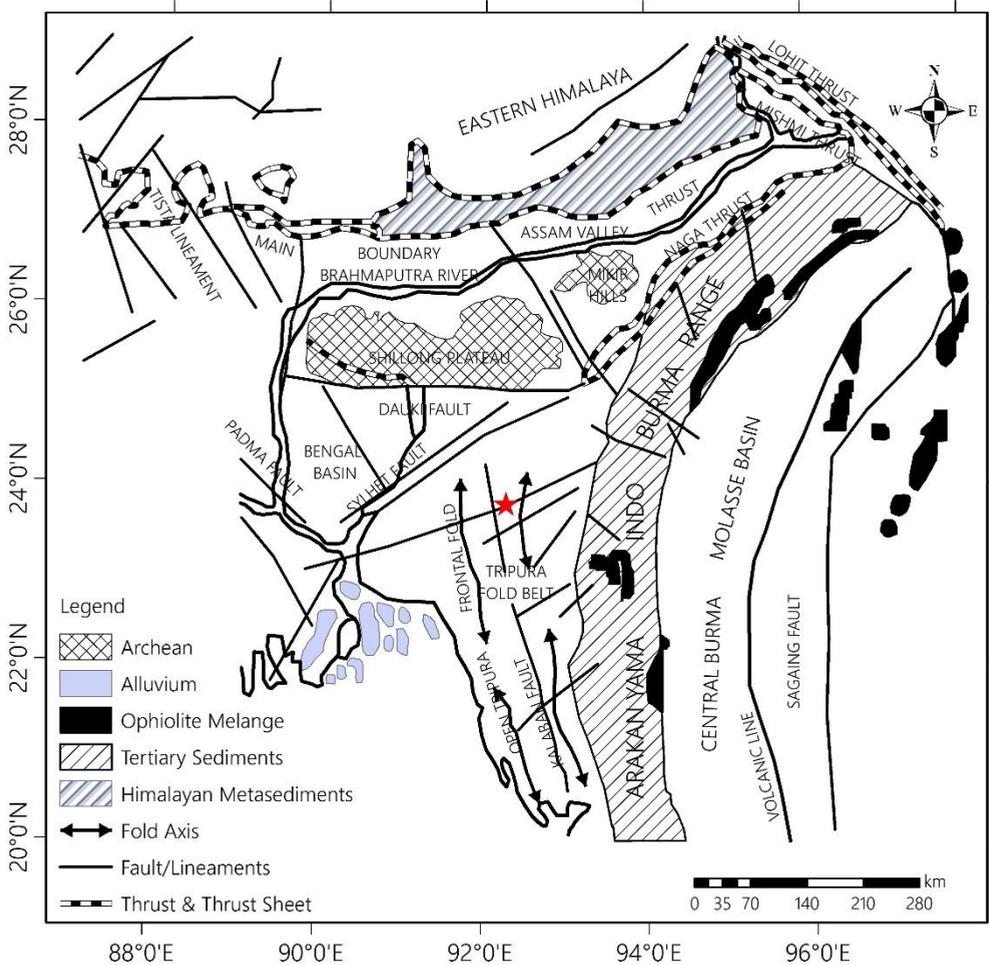
Figure 3. Tectonic map of Northeast India and surroundings. From “A note on earthquake of magnitude 5.5 M_L of January 3, 2017 in Tripura Mizoram border area, India” by Geological Survey of India, 2017. Copyright 2021 by Geological Survey of India. The star within the map shows the location of the epicenter of Tripura earthquake.

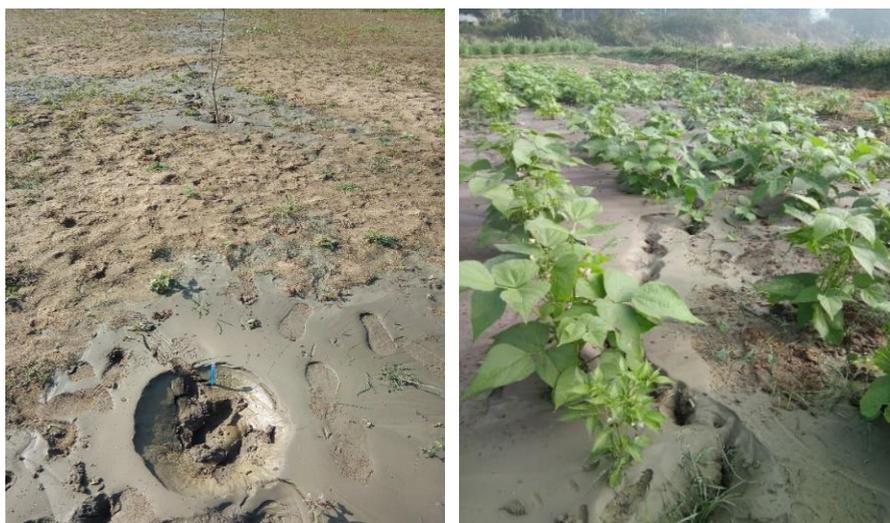
Liquefaction is observed when there is a rapid loss of strength in saturated and cohesionless soils due to dynamic loading, especially during an earthquake. This soil liquefaction was also observed after January 3, 2017 earthquake in the epicenter region of Tripura (Figure 4). This striking feature of earthquake occurred in the flood plain area of the Manu River in Kanchanbari region of Tripura.

Local people witnessed and observed the sand boil features in the agricultural land. They reported that sand spouting continued up to 15–20 minutes after the earthquake. The extent of the liquefaction occurred within the flood plain of the Manu River. Typically, the River Manu is famous for its dynamic nature (Debnath, Das (Pan), Sharma, & Ahmed, 2019) and the present epicenter area as part of its dynamic nature has been formed by the river deposition. According to Anbazhagan et al. (2019), the presence of the sediment and the existence of a water table near the surface could be a reason for the liquefaction in this area.

Figure 4. Soil liquefaction after the earthquake at Kanchanbari, Tripura.
(Photograph taken on January 4, 2017; Location: 24.11°N; 91.99°E).

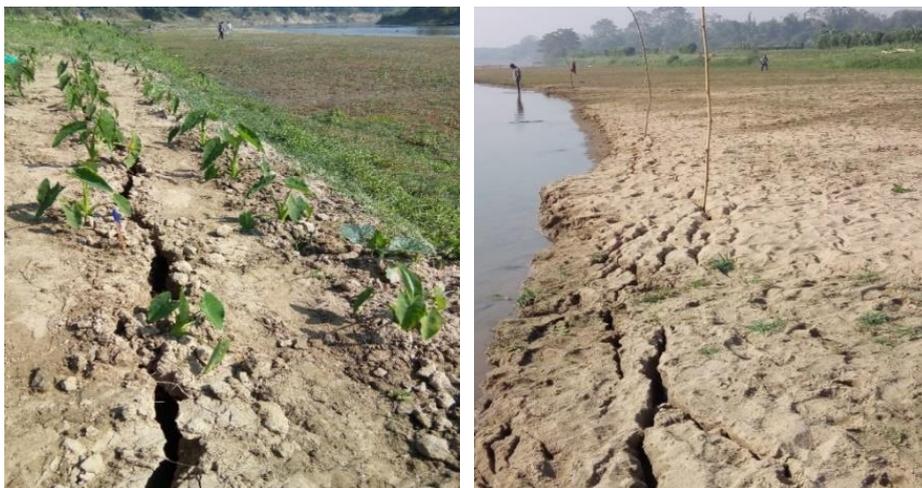
Bank erosion due to liquefaction and mud cracks is common for erosion-prone rivers. Generally, the formation of mud cracks is a preparatory rather than erosive process. It includes wetting and drying of the soil and leads to the weakening of the bank prior to fluvial erosion responsible for the block erosion in a river (Kotoky, Bezbaruah, Baruah, & Sarma, 2005). On the other hand, leaching of the clay minerals also influences bank erosion (Thorne & Osman, 1988). The earthquake occurred in the bank of Manu River which is famous as an erosion-prone river of Tripura. According to the local perception of Kanchanbari (epicenter of the earthquake), this area is already experiencing bank erosion due to the Manu River. Moreover, the meandering nature of the river also indicates that the area is already an erosion-prone zone. Several cracks with the soil liquefaction were observed along the bank of the Manu River in the epicenter area after the 2017 earthquake (Figure 5).

Figure 5. Fractures in the Manu River bank after the earthquake at Kanchanbari, Tripura. (Photograph taken on January 4, 2017; Location: 24.12°N; 91.99°E; Line of sight is towards NE).

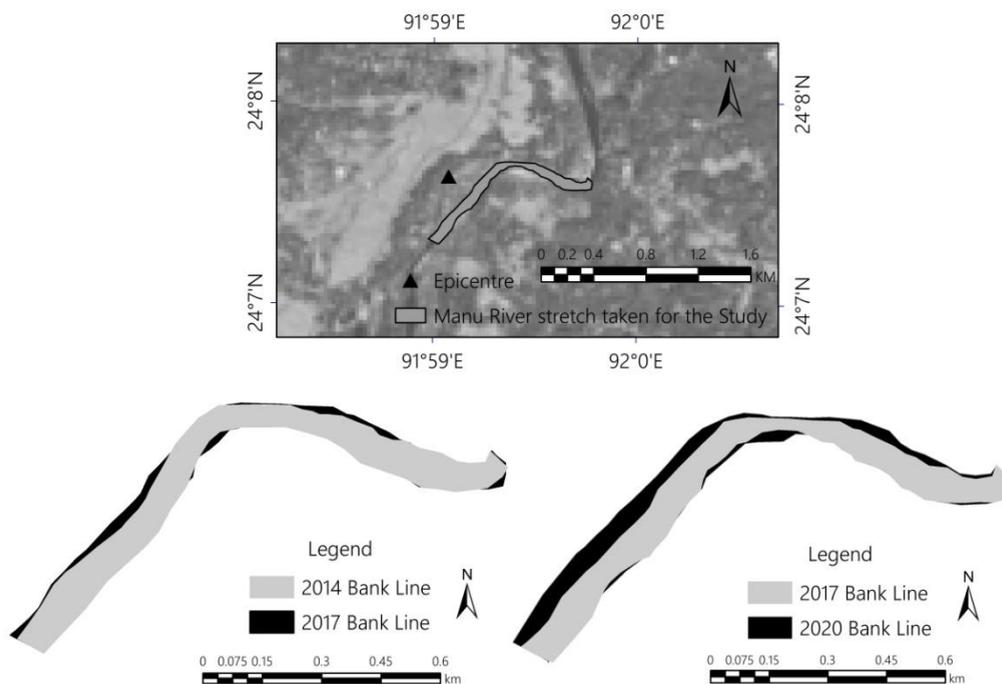
Figure 6. Shifting of the Manu River planform near the epicenter of the 2017 earthquake for the period of 2014–2017 and 2017–2020.

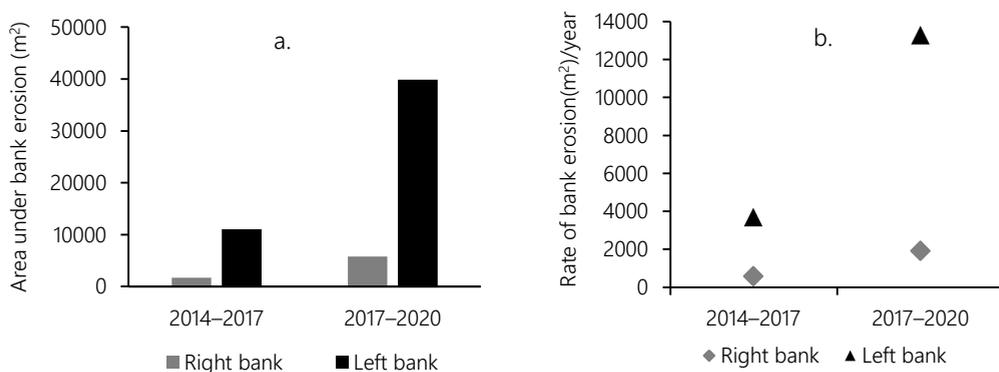
These factors have weakened the soil, reduced the resistance power of the bank, and led to the cogenetic reason for bank erosion. Generally, to realize the impact of the 2017 Tripura earthquake on the bank erosion, the present research examined the channel of the Manu River up to 1 km stretch near the epicenter. This bank erosion was assessed for the period of three years before and after the 2017 earthquake. The pre-earthquake period comprised the period 2014–2017 and post-earthquake period was from 2017 to 2020. The epicenter of this earthquake, i.e., the Manu Riverbank at Dhalai, was visited twice after the earthquake (during 2017 and 2020) and the prominent left bank erosion of the channel was observed. The overlaid channel of the two periods also expressed a similar direction of lateral erosion within the study reach (Figure 6). During the pre-earthquake study period, the area under erosion in the Manu River's left bank was 11,063 m² (Figure 7a), with a rate of 1,918 m²/year (Figure 7b).

Figure 7. Area under bank erosion (a) and rate of bank erosion (b) for the periods 2014–2017 and 2017–2020.

On the other hand, during the post-earthquake period, the area under erosion covered 39,865 m², with a rate of 13,288 m²/year. Similarly, the right bank also experienced increased erosion but lesser than the left bank. Thus, it was noticed that since the 2017 earthquake, the area under bank erosion and the rate of the bank erosion of the River Manu increased to 260% and 592% respectively near the epicenter.
