Original scientific paper

DEBRIS FLOWS IN KRESNA GORGE (BULGARIA)—GEOMORPHOLOGICAL CHARACTERISTICS AND WEATHER CONDITIONS

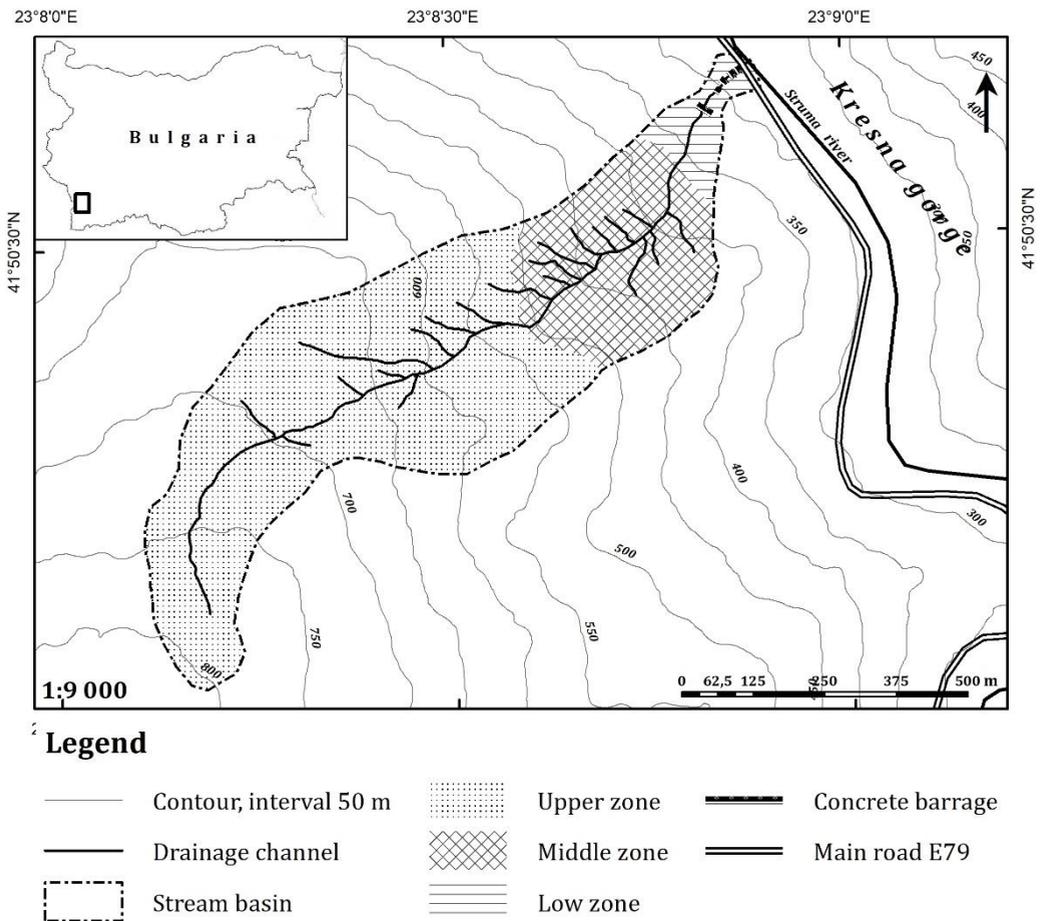
Figure 1. Study area.

The study catchment is located on the eastern slope of the Maleshevska mountains, at the beginning (northern part) of the Kresna Gorge, southwestern Bulgaria (Figure 1). The catchment has an area of 0.38 km². The source of the stream is at the height of 776 m a.s.l. and inflows from the right side into the Struma river at 276 m a.s.l.

The stream is of the second order and has the length of the long profile of 1.54 km (Table 1). Drainage pattern is formed of first-order streams with high drainage density (8.73 km/km²). Based on the collected field data, digital spatial data and some calculated morphometric parameters in GIS environment (slope inclination, local elevation range, and drainage density) allowed us to define three different zones in the catchment—upper, middle, and low zone (Figure 1).

The upper part of the catchment is between 770 and 500 m a.s.l. The slopes at this height are gentler and vary between 10° to 25° and the stream bed inclination is around 10°–15°. The vegetation cover is very rare at this part of the catchment and slope wash processes and semi-active fluvial channels predominate. At about 680 m a.s.l. two first-order flows form the second-order stream.

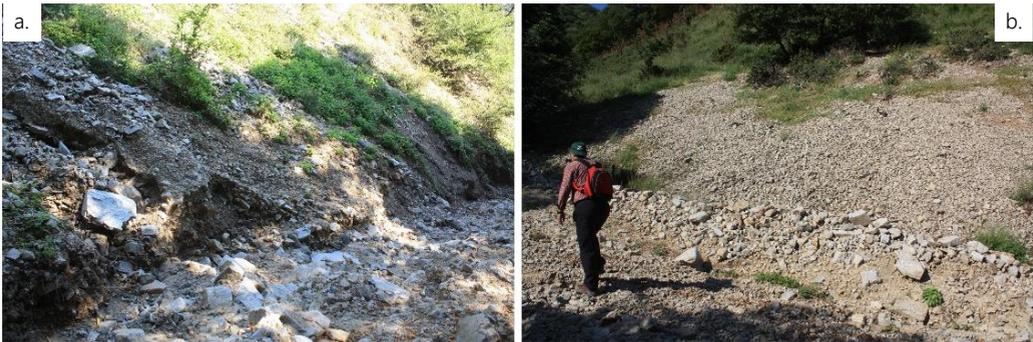
Figure 2. Left (a) and right (b) slopes in the middle zone of the basin.

The most common landforms on the left slope in the middle part of the stream basin are screes and rock falls. They "start" from the rock escarpment, with the size up to 10–15 m², and at the footslope, they form well—shaped cones and screes. In the mid-slope area, between the rocky slopes and the cones, there are small temporary channels (Figure 2). There are also inactive (or older) cones that do not reach the stream bed and form small block fields with an irregular shape.

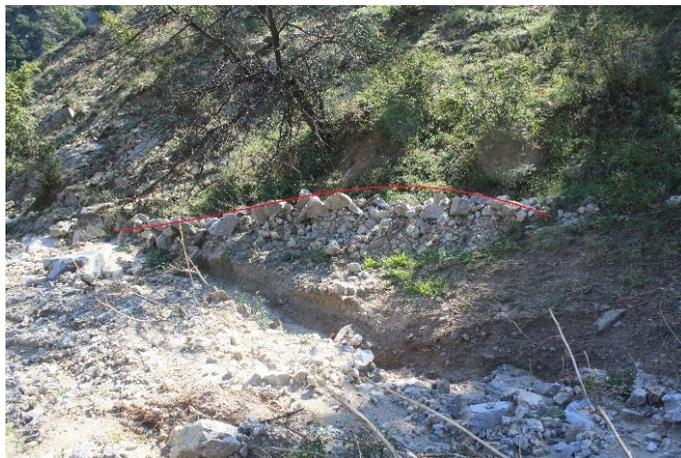
Figure 3. Bars near to the stream bed, marked with red line.

On the right slope of this part of the stream basin, the creep processes predominate. In places where the slope is around 30°, the upper part of the soil is disturbed and forms terracettes with a height up to 20 cm. The channel in this part of the basin is cascade and step-pool and there are 5 more rock thresholds with heights between 2 and 4 m. On the relatively flat area between them, near the channel bed, the bars with a height of 2 m can be seen (Figure 3).

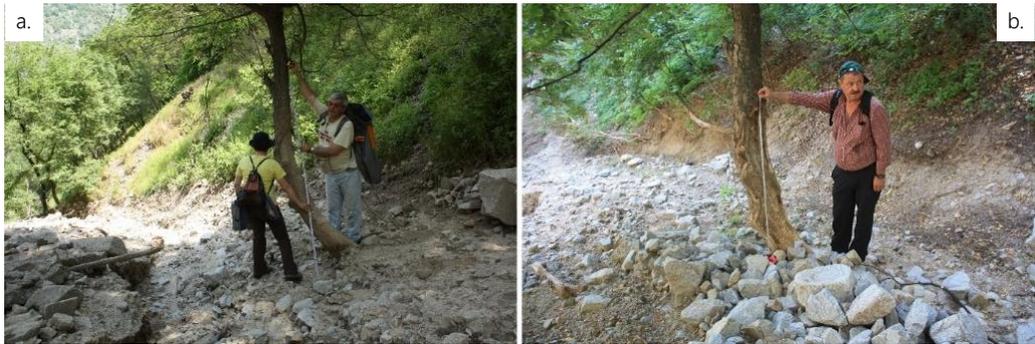
Figure 4. The scars on the tree in the stream bed in June 2009 (a) and August 2019 (b).

The scars of previous debris flows can be seen on the bark of the only tree in the middle of the stream bed. In 2009 the highest marks on the bark were 1.8 m high. They are still visible, but the bark has partially recovered (Figure 4). In 2019, the highest fresh scars were 1.66 m in height.

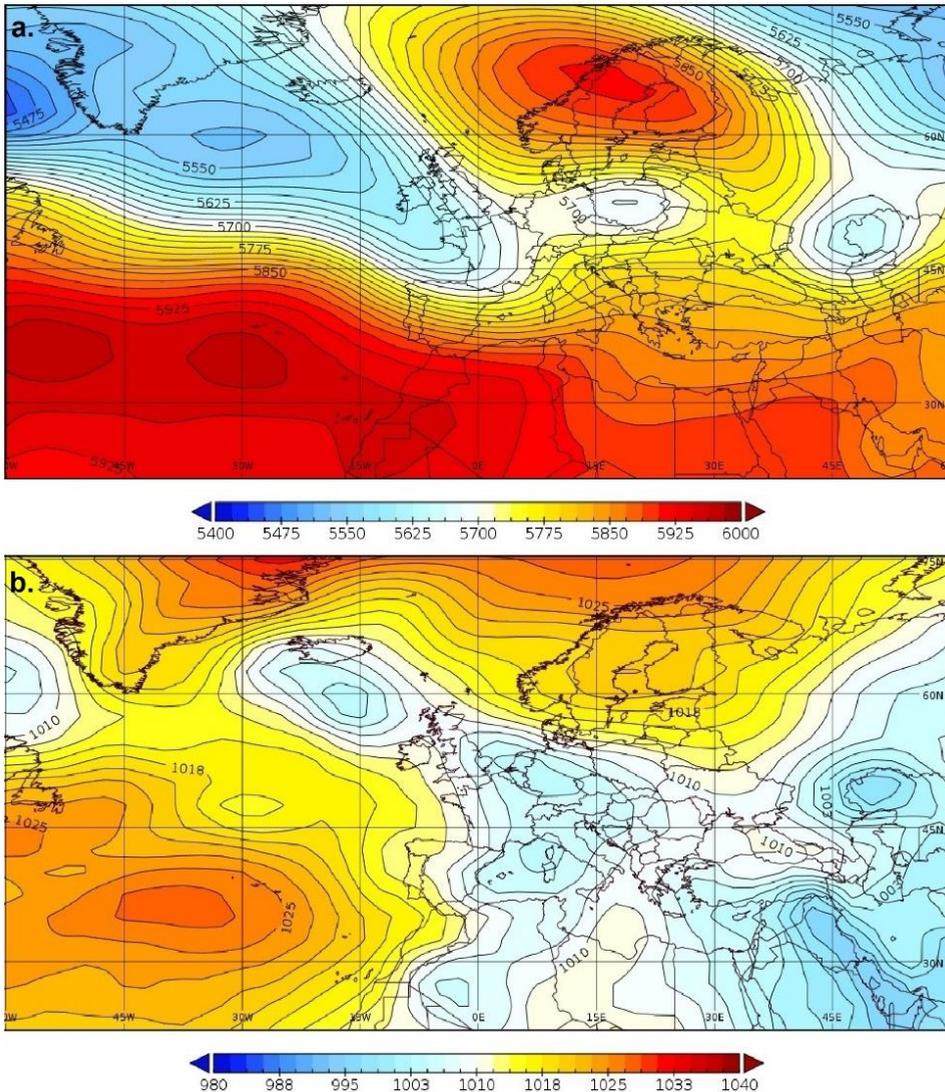
Based on the used reanalysis data we have analyzed the weather conditions over Europe and Bulgaria in particular for the day July 27, 2019 that led to the intense rainfall and related debris flows. On July 27, 2019 at the level of 500 hPa a wide ridge covering wide part of Europe, reaching north to

Scandinavia was observed (Figure 5a). At the same time, from the North Atlantic through Western Europe to the Mediterranean, a cyclonic throw is formed, that breaks the ridge, over the central parts of the continent and over the western half of the Balkans. A multicenter area of low pressure exists at the ground layer above Central Europe, while above Scandinavia, European Russia, and Ukraine there is a high pressure ridge, whose main center is far north in the Arctic (Figure 5b).

The results from the present study coincide with Godev (1976) and show that the cyclonic baric field (Figure 5), air humidity between 50 and 90% (Figure 6) in the layer from 1500 to 5000 m, mountainous terrain, and overheating of the air are favorable conditions for the occurrence of powerful convective clouds with torrential rainfalls.
